**ANALYTICAL RESULTS REPORT
SITE INSPECTION**

CALMET

EPA ID # COD983767443

**U. S. ENVIRONMENTAL PROTECTION AGENCY
REGION VIII**

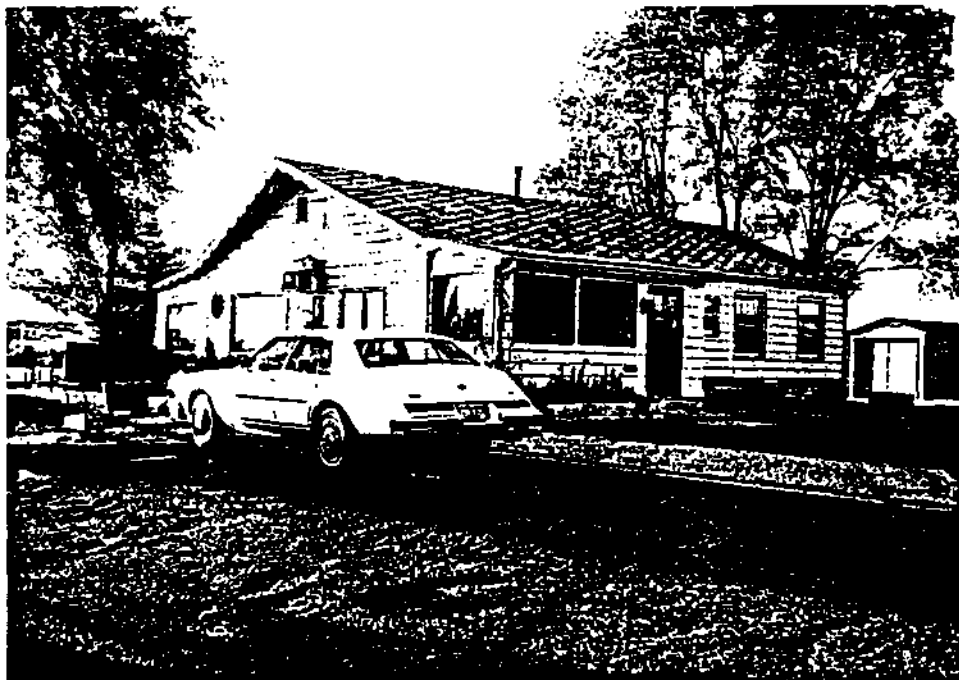
Description Warnecke residence at 1718 Rustique Drive.

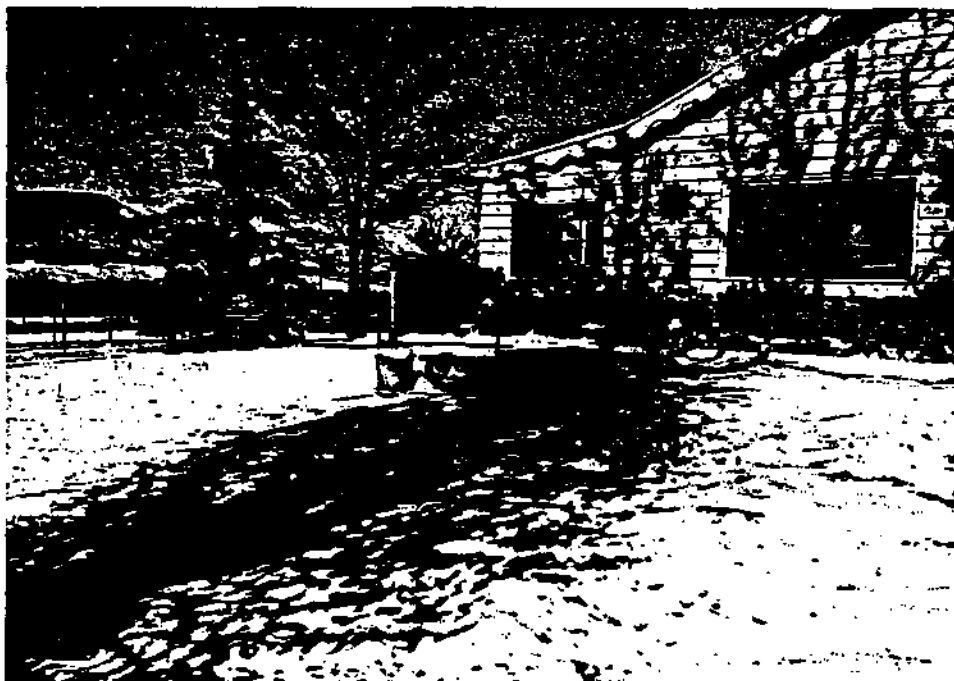
Description Wellhead and hand pump for well at 1718 Rustique Drive. Low structure behind well is a cover for the hand-dug well.

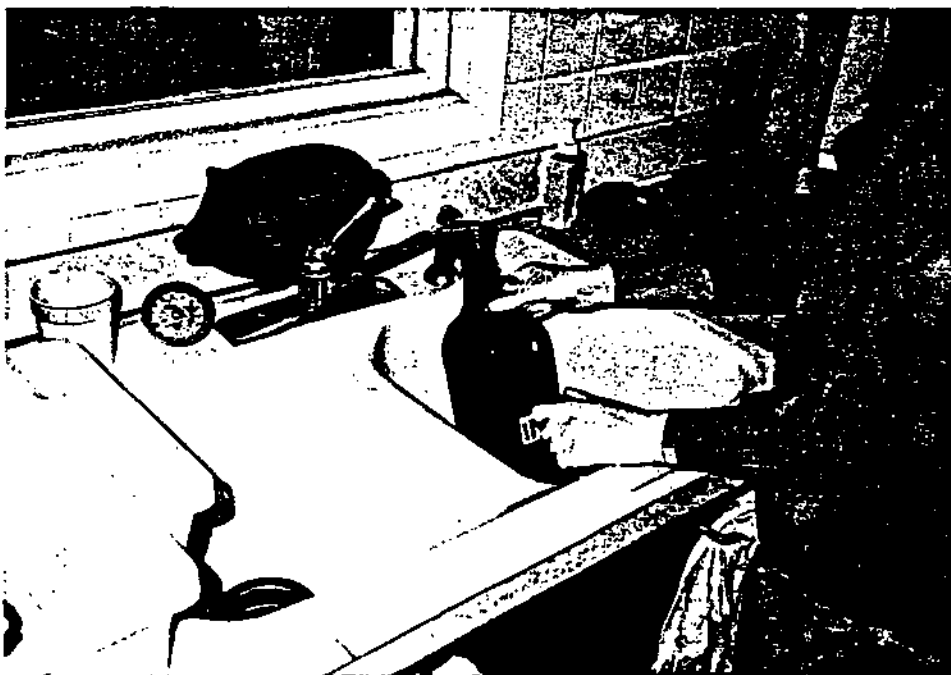
Description Kitchen sink at 1718 Rustique Drive. Sample CA-GW-1 was collected from the faucet.

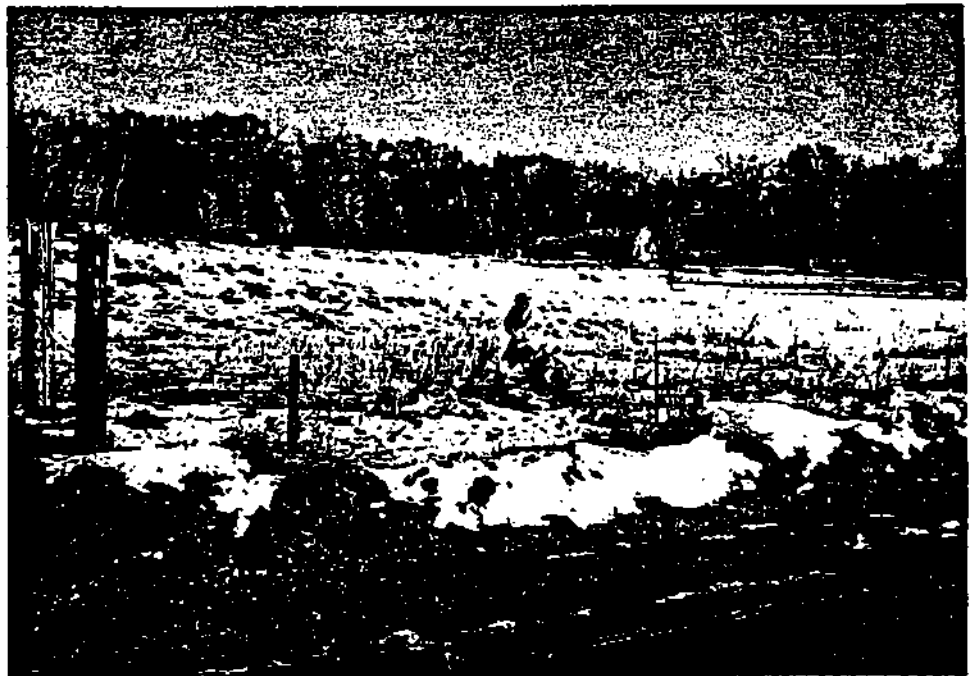
Description Background soil sample CA-SO-1. Fence posts at left are northwest corner
of property at 1601 Rustique Drive.

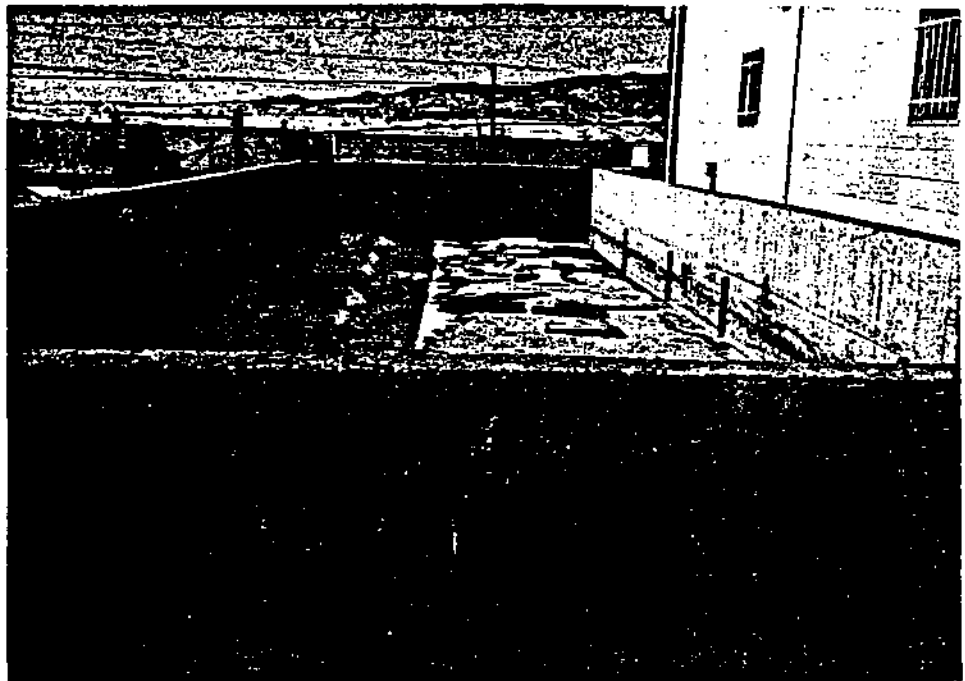
Note stains on berm walls.
